Karluk River Weir

At last! Accurate counts of spawning salmon.

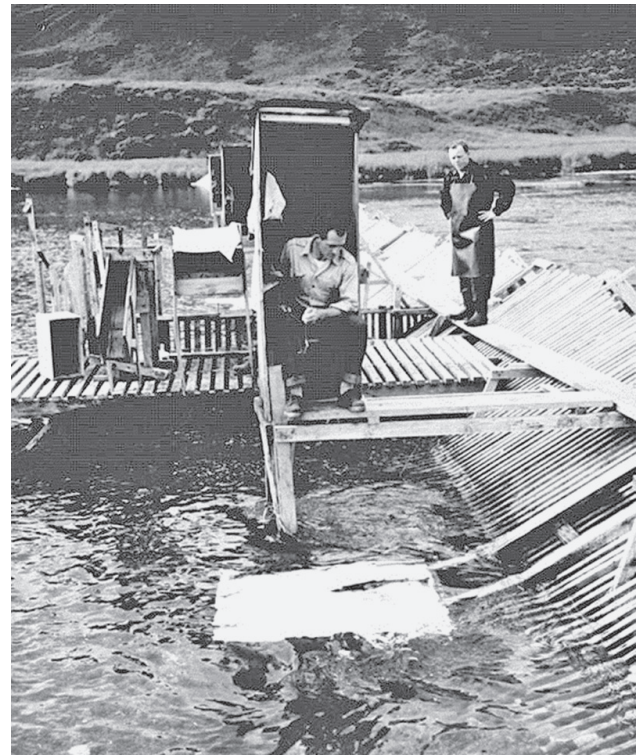
Counting sockeye salmon as they come through the Karluk River weir, September 1948. (E. P. Haddon, Auke Bay Laboratory, Auke Bay, AK, FWS-1223)

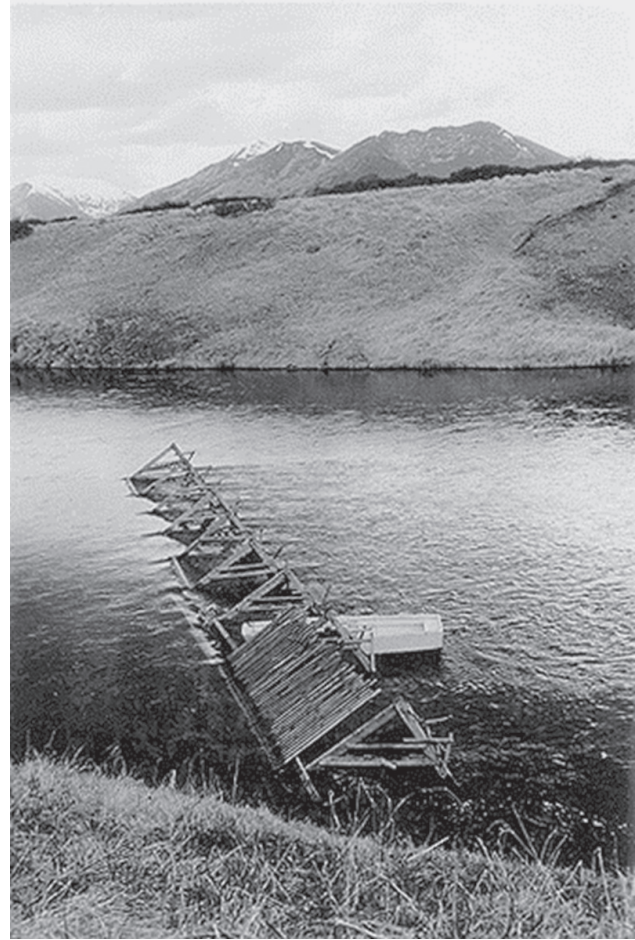
Dolly Varden temporary angled weir, Karluk River Portage, May 1941. (Allan C. DeLacy, from Catherine J. DeLacy, Seattle, WA)

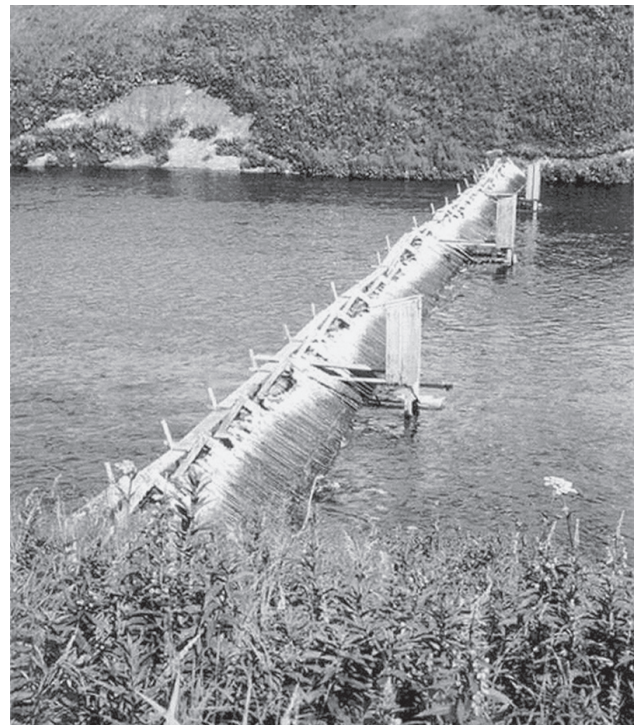
Karluk River salmon counting weir at the Portage, 1944. (Jerrold M. Olson, Auke Bay, AK)

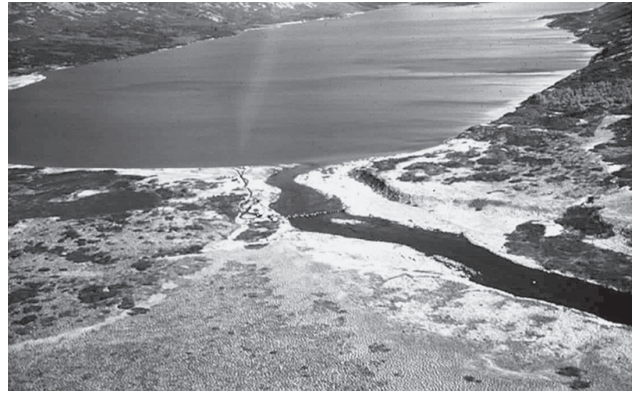
North end of Karluk Lake and salmon counting weir located in upper river near lake's outlet, May 1957. (Auke Bay Laboratory, Auke Bay, AK)

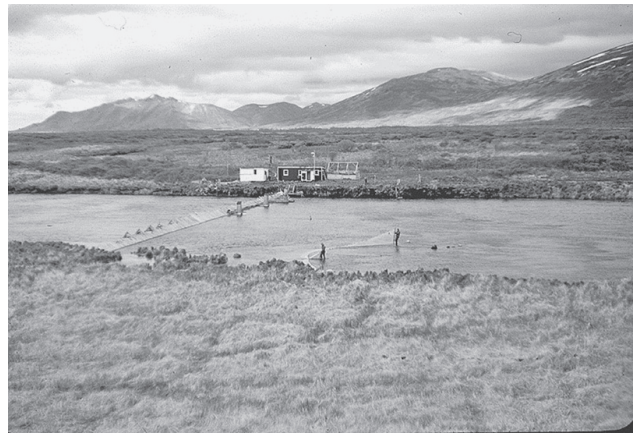
Karluk River salmon counting weir and cabin near Karluk Lake's outlet, ca. 1952. (Charles E. Walker, Sechtel, BC)

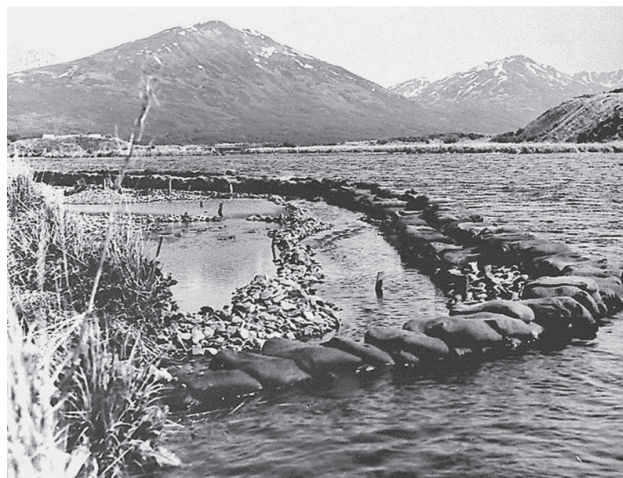
Coffer dam for construction of a two-way permanent salmon counting weir, upper Karluk River, June 1949. (Richard F. Shuman, Auke Bay Laboratory, Auke Bay, AK)

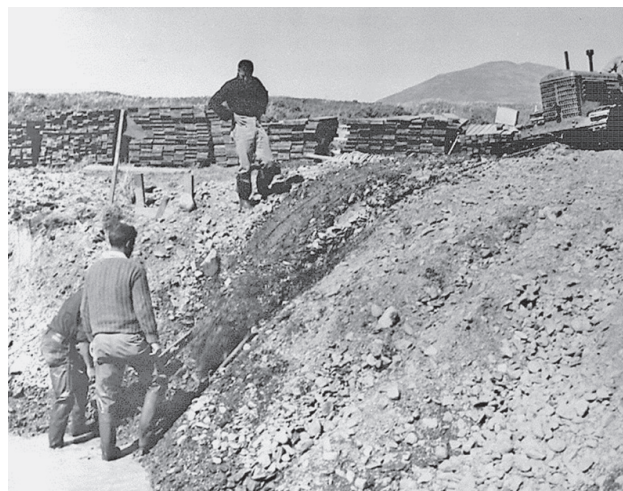
Excavating footing for a two-way weir, upper Karluk River, June 1949. (Richard F. Shuman, Auke Bay Laboratory, Auke Bay, AK)

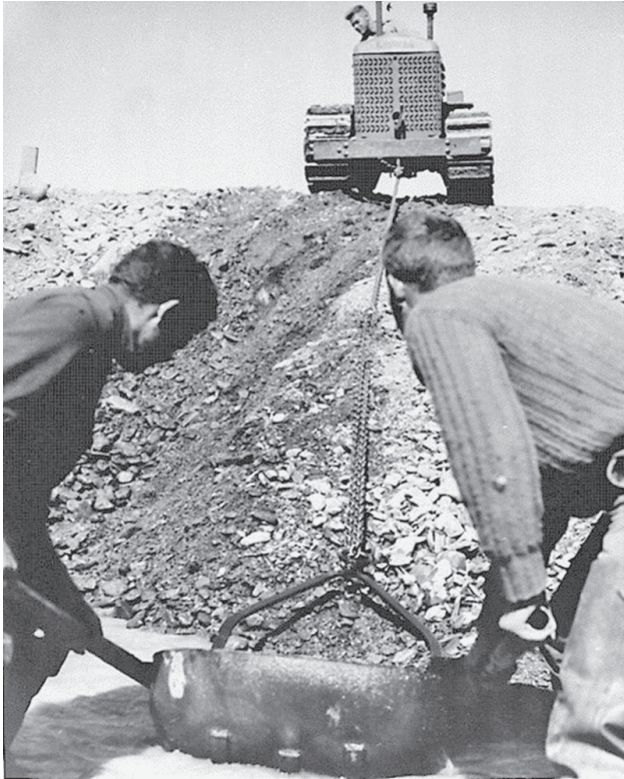
Using a slip scraper and Cletrac tractor to excavate the footing for a two-way weir, upper Karluk River, June 1949. (Richard F. Shuman, Auke Bay Laboratory, Auke Bay, AK)

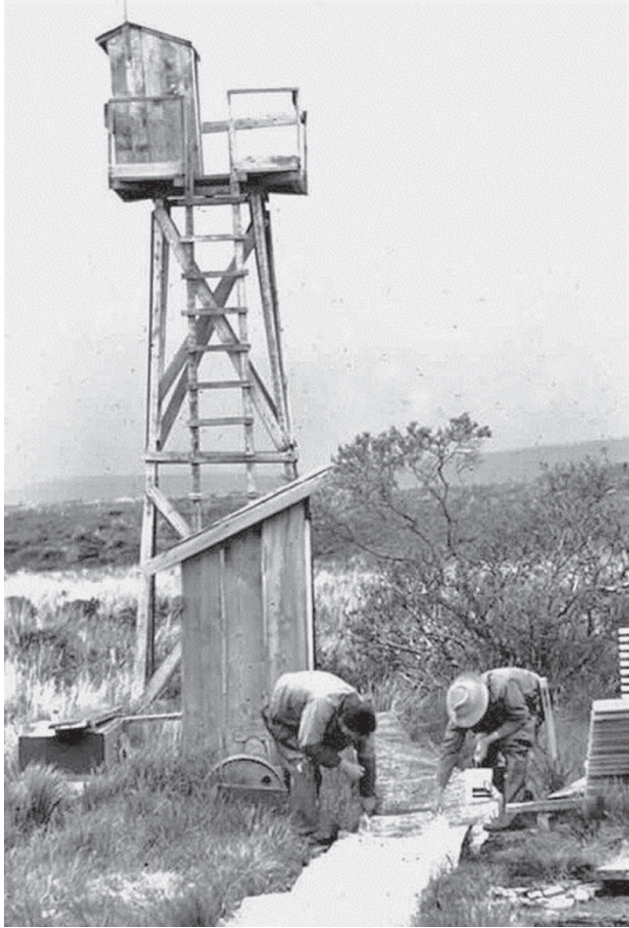
Counting tower used to enumerate adult sockeye salmon, upper Karluk River, June 1958. (Auke Bay Laboratory, Auke Bay, AK)

remedy this, they installed a fence across part of the river, leading the salmon toward a 20 m wide opening nearer the tower. To further improve visibility, they placed white panels (2.1 m wide) on the river bottom to increase contrast between the salmon and substrate. These changes improved the counting effort, but altered the salmon's migratory behavior. First, just as the previous wooden picket weir had done, the installed fence hindered the downstream movements of salmon. Second, the white river panels made salmon reluctant to continue upstream. They gathered just downstream of the panels until a sufficiently large school had accumulated, and then rapidly crossed the white strip in a flowing mass. The white panels needed constant cleaning since passing fish covered them with gravel.

each autumn, fish moved both upstream and downstream past the tower and this required that counts be tallied in both directions to determine the net migration. Counting was further complicated in autumn since both unspawned and spawned-out sockeyes moved downstream past the weir; counts of only the former were subtracted from the upstream migration. Therefore, observers had to tally salmon numbers moving in different directions and also instantly recognize species and spawning condition from a long distance—this supposedly simple task was overwhelming.
