## AN EVALUATION OF THE AIR BUBBLE CURTAIN AS A BARRIER TO ALEWIVES

By George A. Kupfer\* and William G. Gordon\*\*

The effectiveness of an air bubble curtain to impede, redirect, or stop the annual migration of alewives in the Milwaukee River was studied in the spring of 1964. Its operation during a  $1\frac{1}{2}$ -month period indicated that the curtain reduced the migration of alewives.

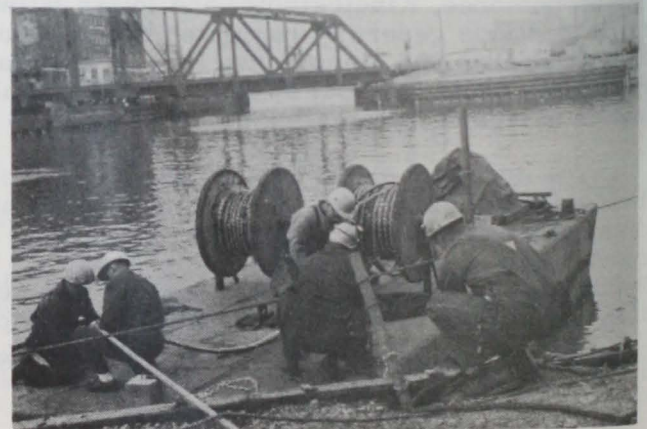
Fig. 3 - Barge used to place air hose.

**THE PLASTIC HOSE:** Two lengths of plastic hose, rated to withstand 100 pounds per square inch, were connected by a regular air hose reducer fitting. The first 250 feet of this hose was 1 inch in diameter and the remaining 250 feet was  $\frac{3}{4}$ -inch diameter. Holes (0.0135-inch diameter) were drilled every 6 inches with a No. 80 jewelers drill. One end of the hose was plugged. A length of  $\frac{3}{8}$ -inch chain was attached along the entire length of the hose by nylon seaming twine to keep the hose on the bottom in the desired position. As the hose was drilled and the chain attached, the two sections were placed on two large reels aboard a barge (fig. 3). This technique made it easy to place hose on the bottom of the river by attaching a line in the desired diagonal across the river and moving the barge along this line (fig. 4). The end of the plastic pipe was secured to a rigid pipe secured to a piling on the west bank of the river (see cover page).

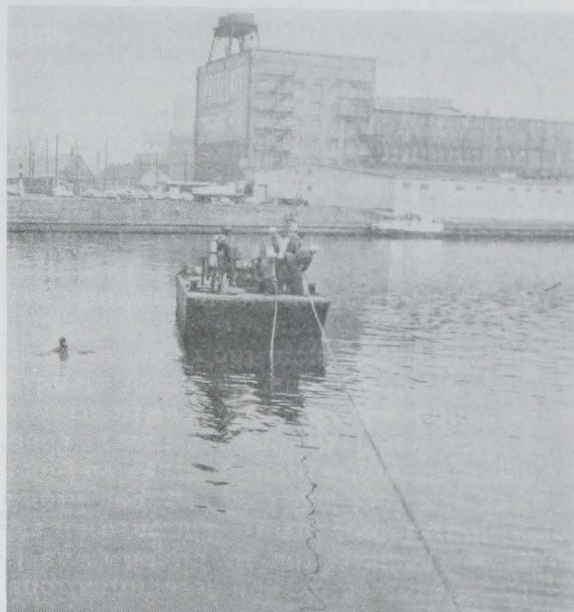
Fig. 4 - Reeling out hose and chain.

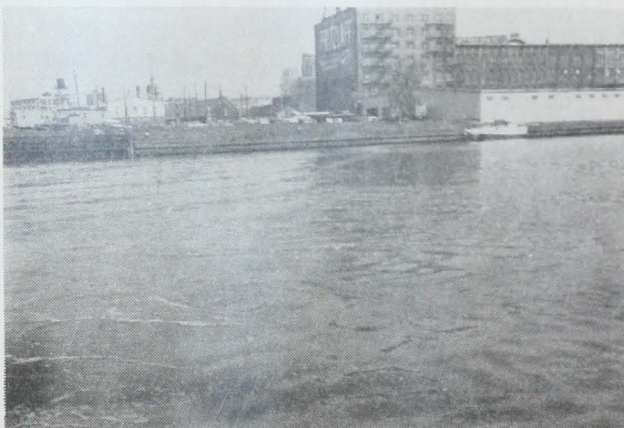
Fig. 7 - Air curtain with holes spaced at 6-inch intervals (0.1 inch in diameter).

... pounds per square inch. During early operation, the air curtain was a solid and continuous stream of readily visible bubbles (fig. 6). As the study progressed the initial holes tended to close, because of the burrs left on the inside of the pipe during drilling. To correct this, CUBA divers punched holes with a fine pin at 2-inch rather than 6-inch intervals. This diameter (0.02 inch) was about double that of the No. 80 drill. The close-spaced holes produced much more vigorous, uniform, and probably more effective curtain (fig. 7). Unfortunately, as the study went on, even the larger holes became partially plugged and the action was reduced.

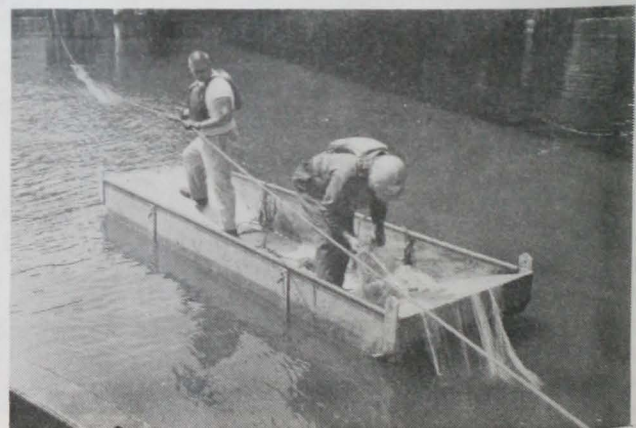
Fig. 8 - Setting test net.

Gill nets, one on each side of the air curtain, were used to evaluate the number of fish traveling through the air curtain. Because the rivers are navigated by pleasure boats and other smaller craft, the nets had to be set below the normal draft of such boats. Gill nets were 6 feet deep by 100 feet long and made of  $1\frac{1}{2}$ -inch (stretch) nylon webbing. These nets extended across the river so that fish near the bottom would be caught no matter at what point in the river they migrated. To minimize the length of the nets needed, one was placed between the abutments of the Buffalo Street bridge and the other between the abutments of the North Water Street bridge (see fig. 2). The width of the river at those points (between the abutments) is about 100 feet. The nets were fished each Monday, Wednesday, and Friday. The nets

we fished a shorter time on days when many fish were present in the netting area. Both nets, however, were fished for the same length of time and during the same period to obtain comparable results. Because of strong currents, a line was attached between the pilings of the bridges, along which a small barge was operated for setting and picking up the nets (fig. 8). As the nets were picked out of the water, the enmeshed alewives were counted and recorded.

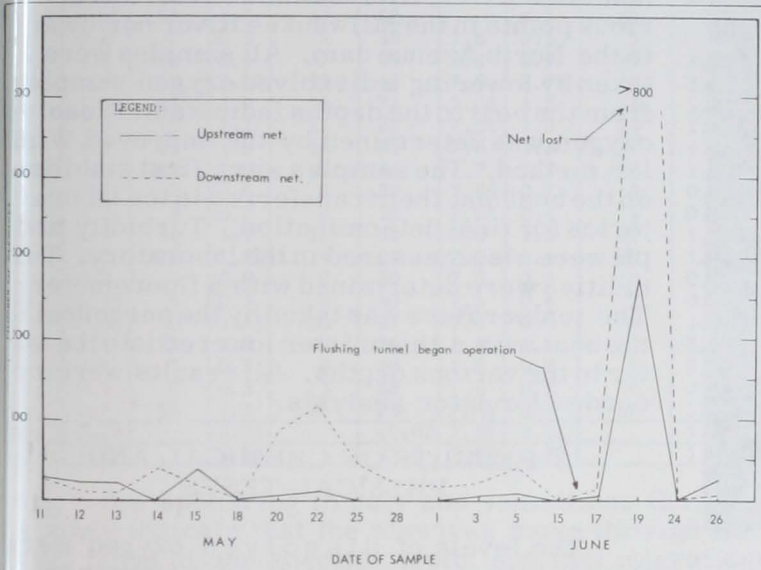
Fig. 9 - Number of alewives caught by gill nets above and below the air curtain during summer 1964.

Gill-netting during the first week gave inconsistent results (fig. 9). At first, the net above the air curtain would have greater numbers of fish than the net below. From May 18 through June 15, 1964, the downstream net consistently caught more fish than the upstream net. The first erratic results may have resulted from fish in the river before the study began.

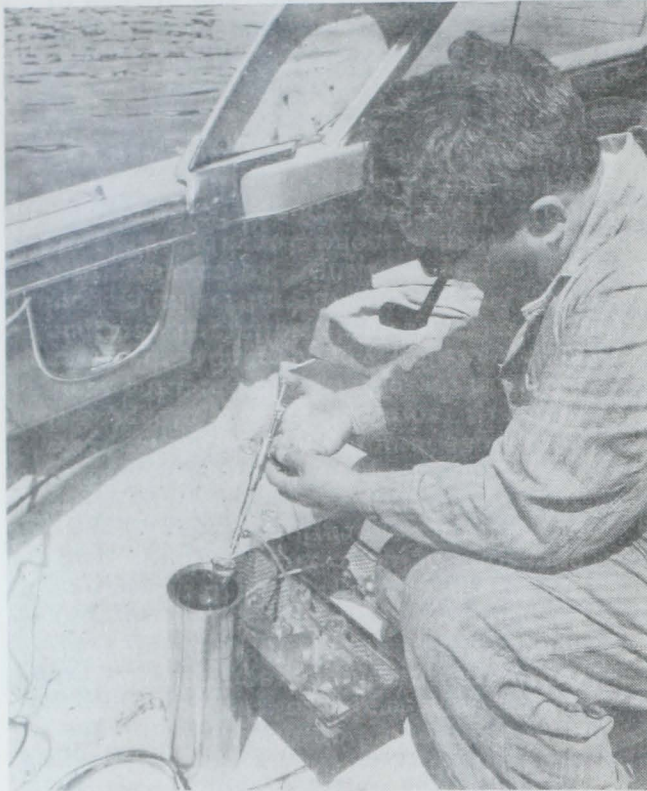
Fig. 10 - Dissolved oxygen determination.

and obtain samples to determine turbidity, dissolved oxygen, and pH (fig. 10). The dissolved oxygen measurements were taken at three points: (1) 25 feet upstream from the air curtain, (2) 25 feet downstream, and (3) 75 feet downstream.

Two samples for oxygen and pH were taken at each of those points, one at the 6-foot depth and the other at the 15-foot depth. In addition, a turbidity sample was taken 25 feet upstream from the air curtain. Other samples also were taken at various other locations in the river system throughout the study period but these are not shown in this report. These included the Menomonee River, Kinnickinnic River, and at various points in the Milwaukee River northward to the North Avenue dam. All samples were taken by lowering a dissolved oxygen sampler from the boat to the depths indicated. Dissolved oxygen was determined by the improved Winkler method. The samples were first stabilized on the boat and then transferred to the laboratories for final determination. Turbidity and pH were also measured in the laboratory. Turbidities were determined with a fluorometer. The temperature was taken by the personnel in the boat with a thermister lowered into the water to the various depths. All results were recorded for later analysis.

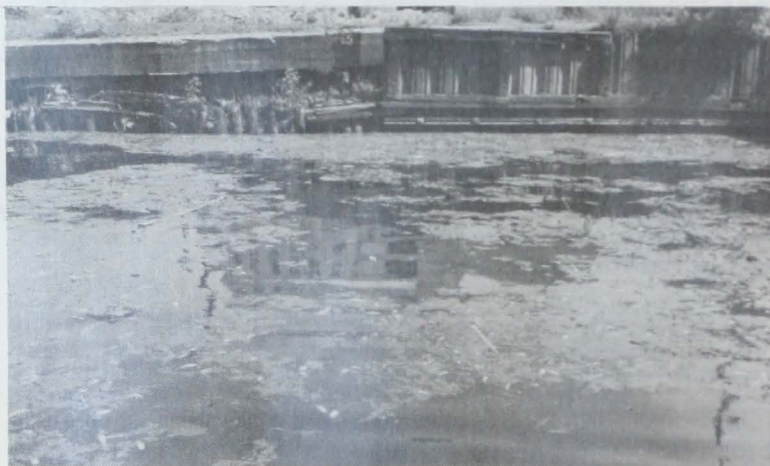
Fig. 11 - Dead fish and debris in river.

Generally, the visual observations revealed large numbers of dead fish below the air curtain and smaller numbers above. The largest numbers of dead fish were noted at the junction of the Menomonee River and in the area of the junction of the Kinnickinnic River. Although dead fish were constantly sighted upstream, it is not known how long they had been dead. Many of the fish above the air curtain were quite deteriorated. Most fish were probably noted several times in the week-to-week searches.
