INJURED AND DEAD FISH IN THE VICINITY OF BONNEVILLE DAM

SPECIAL SCIENTIFIC REPORT: FISHERIES No. 29

UNITED STATES DEPARTMENT OF THE INTERIOR
FISH AND WILDLIFE SERVICE

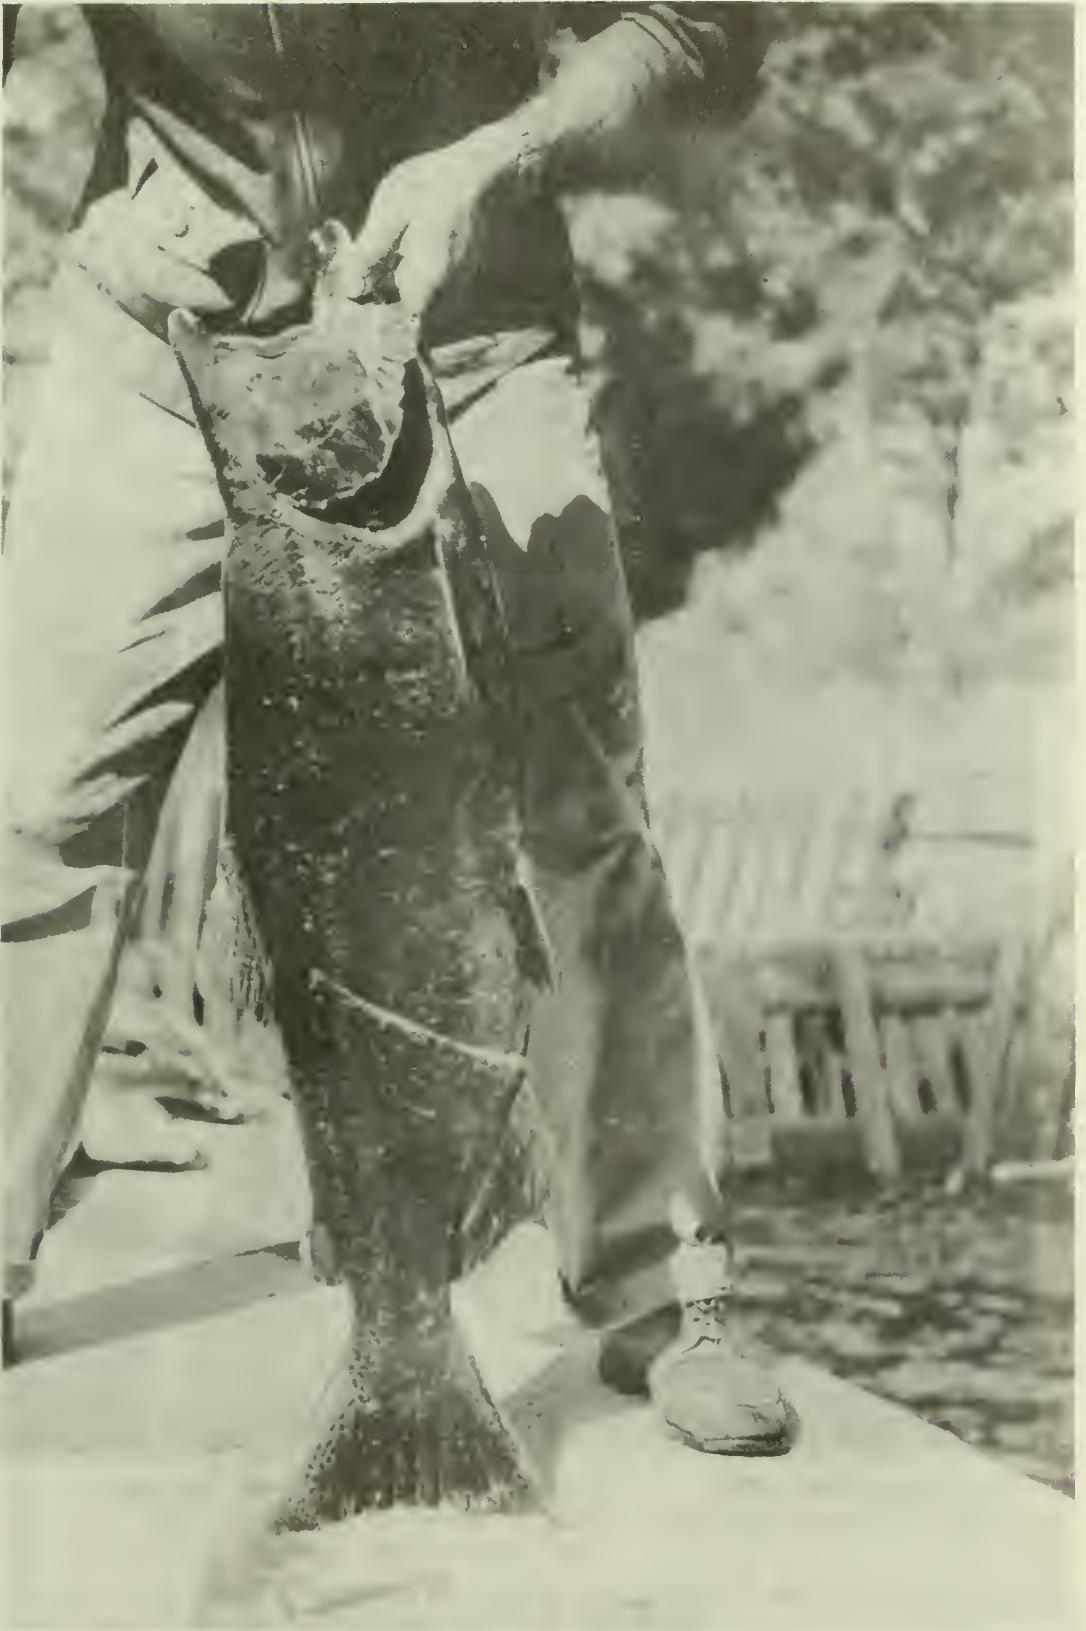
Figure 1.-- Chinook Salmon with dorsal and ventral fin injuries observed at Big White Salmon Hatchery.

Of the 499 fish with dorsal-fin injuries, 78.9 percent had the accompanying ventral-fin injuries. All of the fish with encircling abrasions had both dorsal and ventral cuts. It is apparent in Figures 1 and 2 that these injuries were caused by nets.

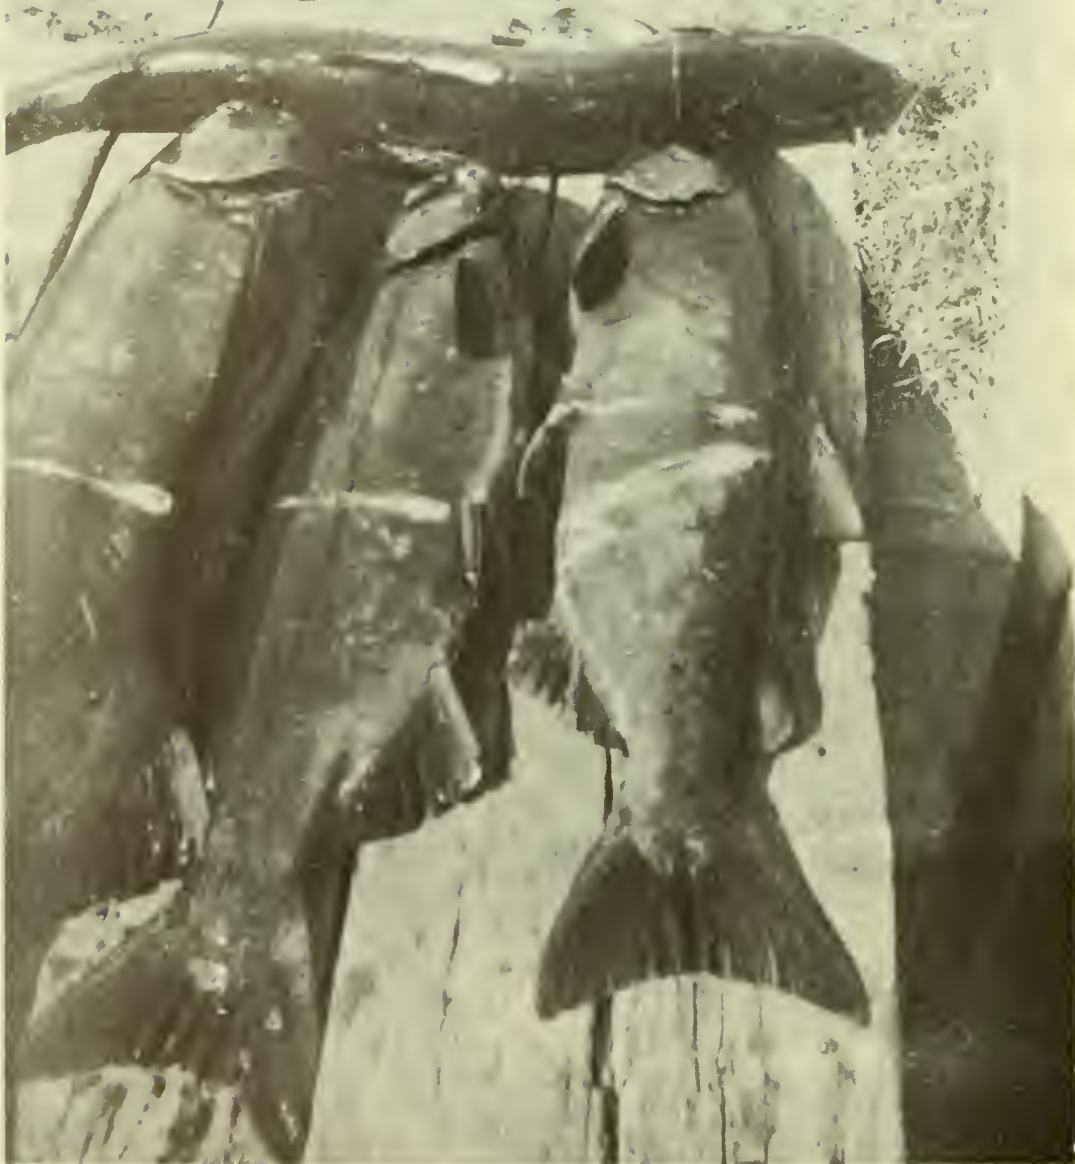
Figure 2.--Chinook Salmon with dorsal and ventral fin injuries plus the completely encircling abrasions observed at Big White Salmon Hatchery.

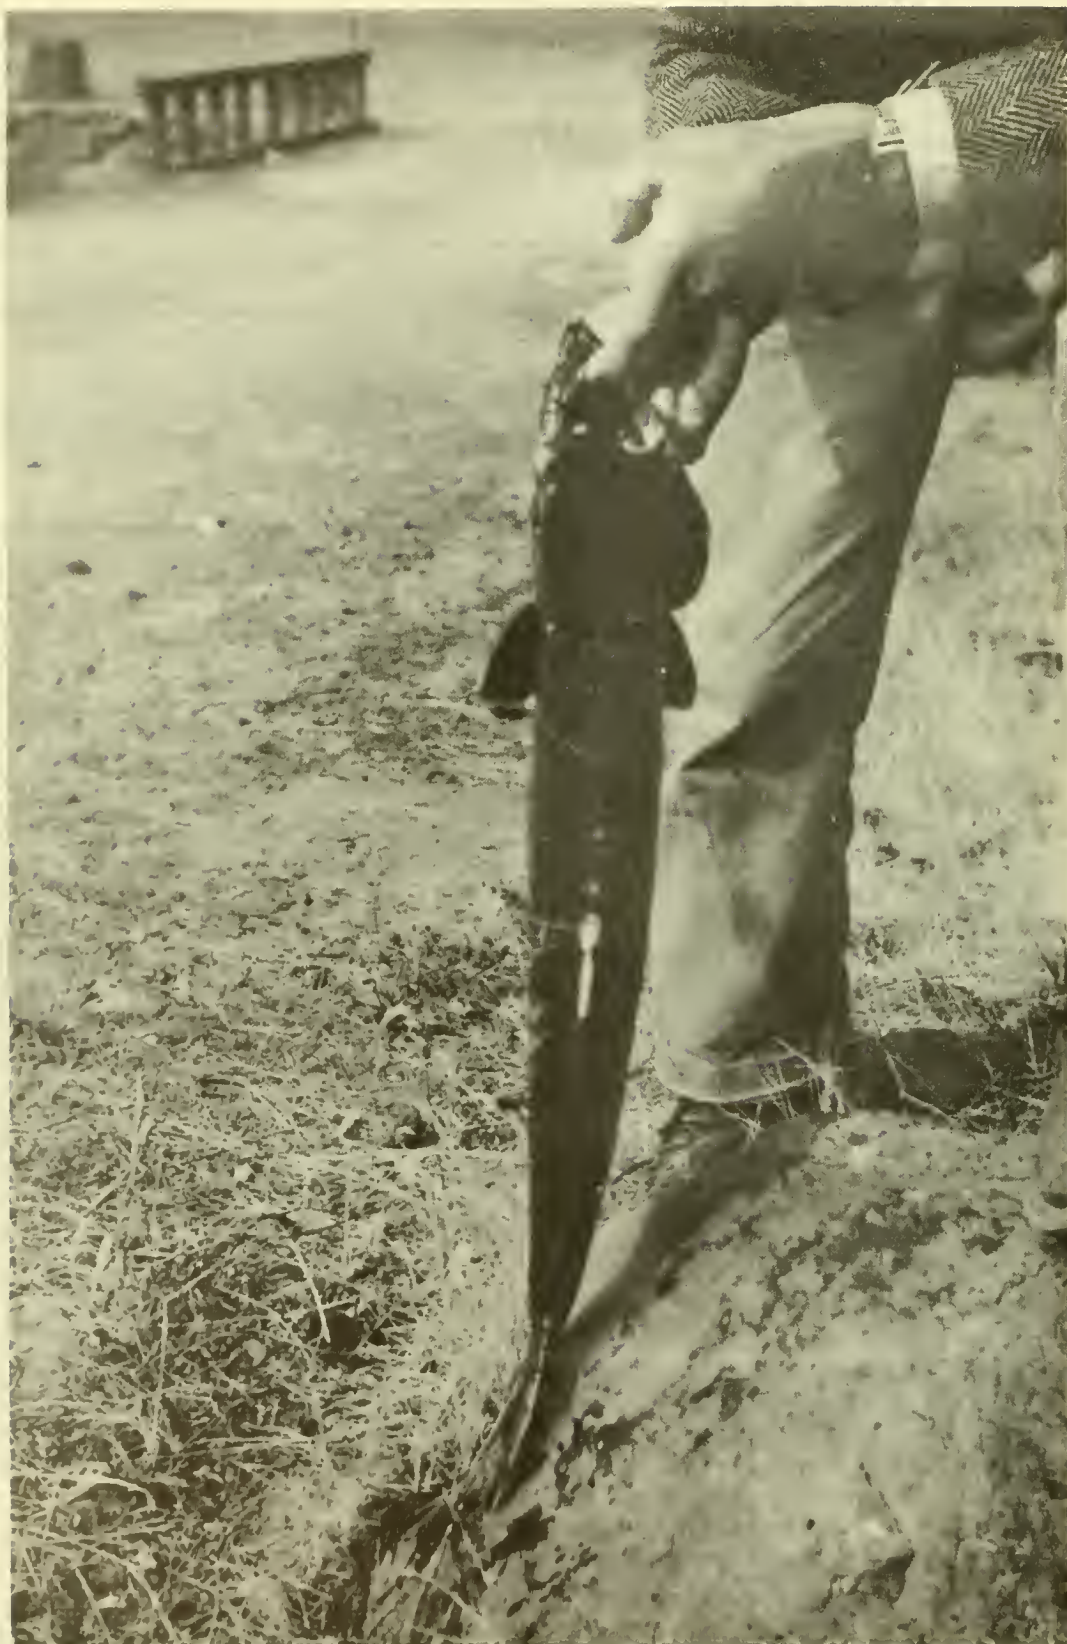
Figure 3.--Chinook Salmon with dorsal fin injuries
observed at Bonneville Hatchery.

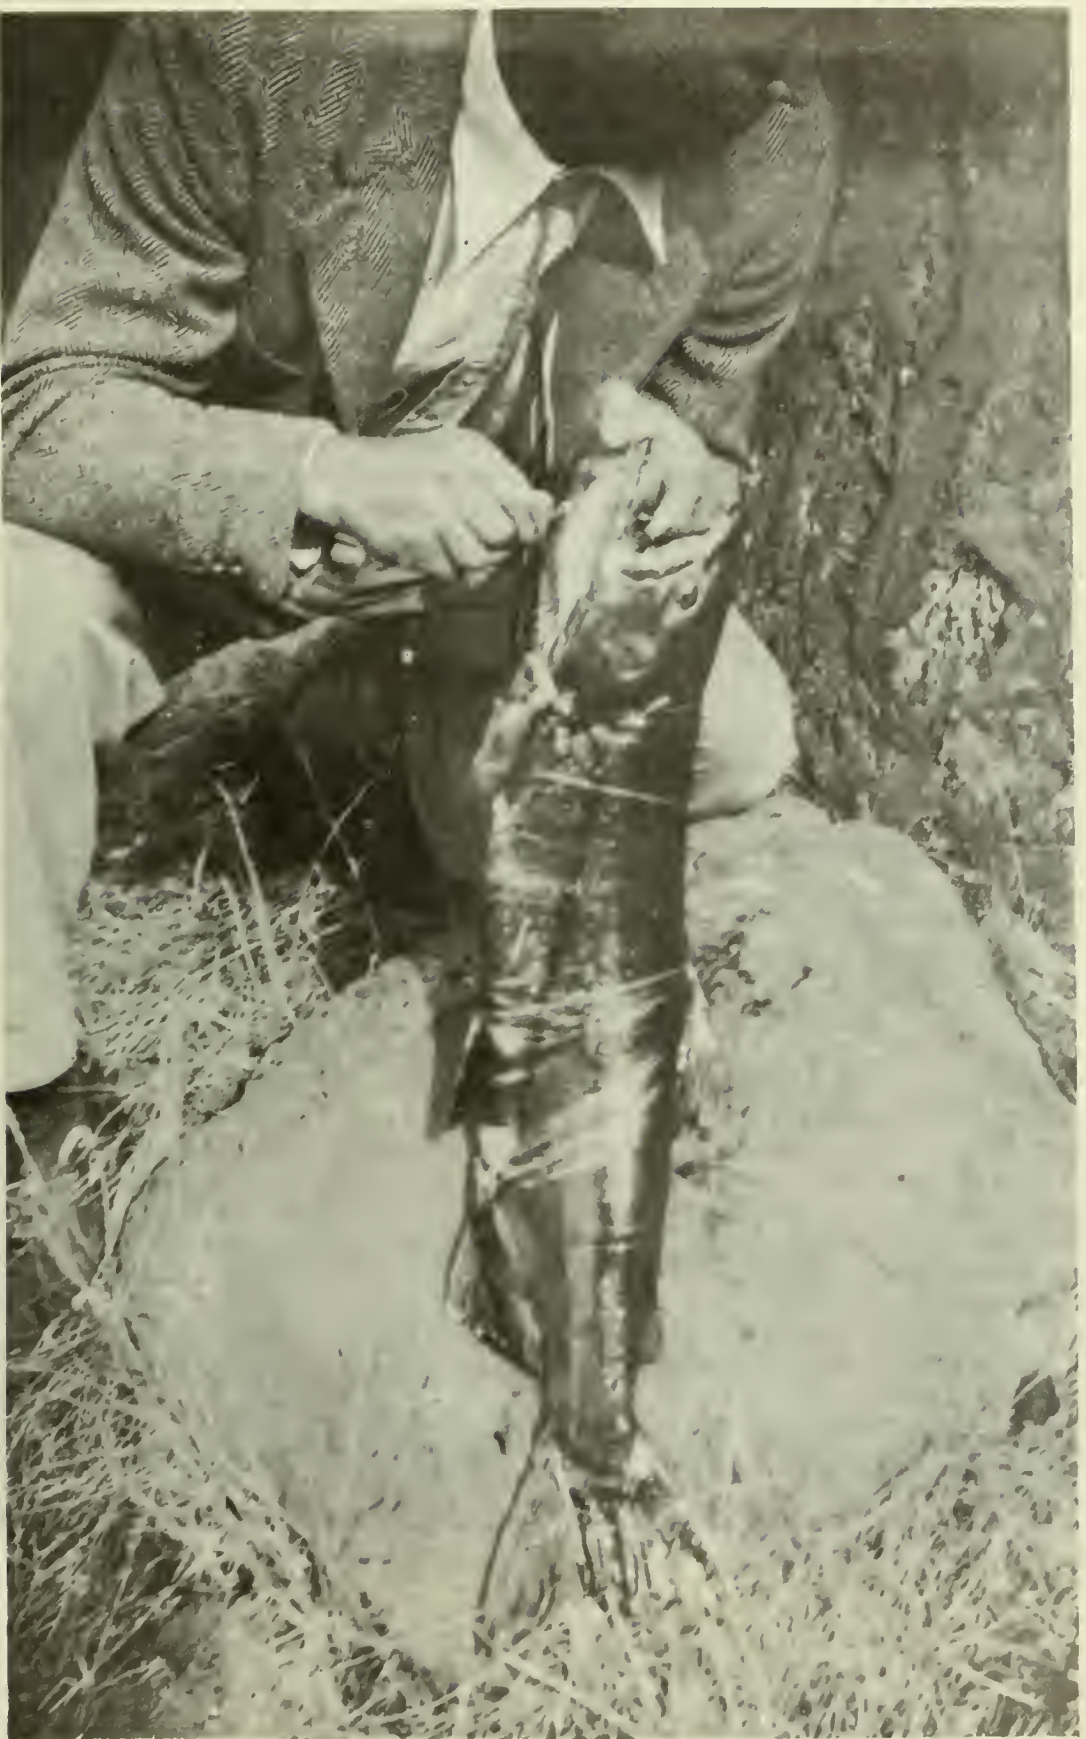
Figure 4.--Chinook Salmon with ventral fin injuries and completely encircling abrasions observed at Bonneville Hatchery.

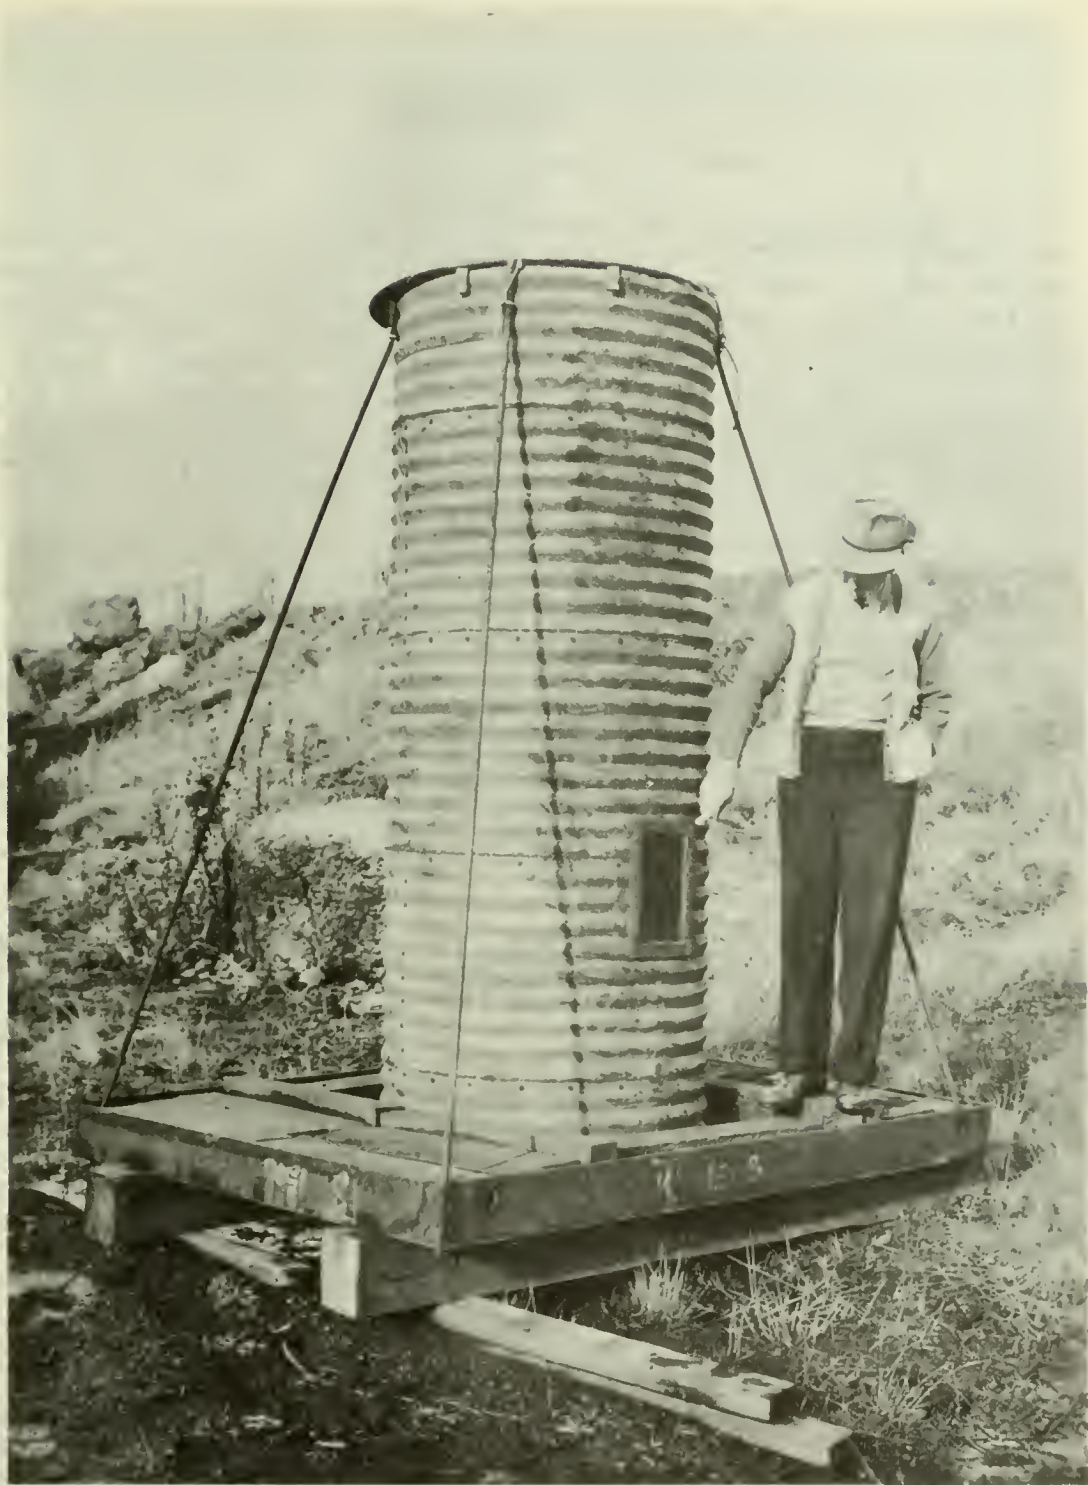
Figure 5.--Submersible chamber built by U.S.
Corps of Engineers to observe fish
movement in the Bonneville fish ladder.

to observe the action of salmon in the Bonneville fish ladders as the fish passed through the submerged orifices in the weirs. Such observations, it was believed, would determine whether or not the injuries observed at the counting stations and at the hatcheries could have been sustained in the ladders. Consequently, the Corps of Engineers built a submersible operation chamber for the purpose (Figure 5).

On September 5, 1946, the observation chamber was lowered into the fish ladder in the first pool below the Bradford Island counting station. From the chamber, large numbers of chinook salmon and steelhead trout were observed passing through the submerged orifice in the lower weir of the pool. The velocity of the water passing through the opening was about five feet per second.

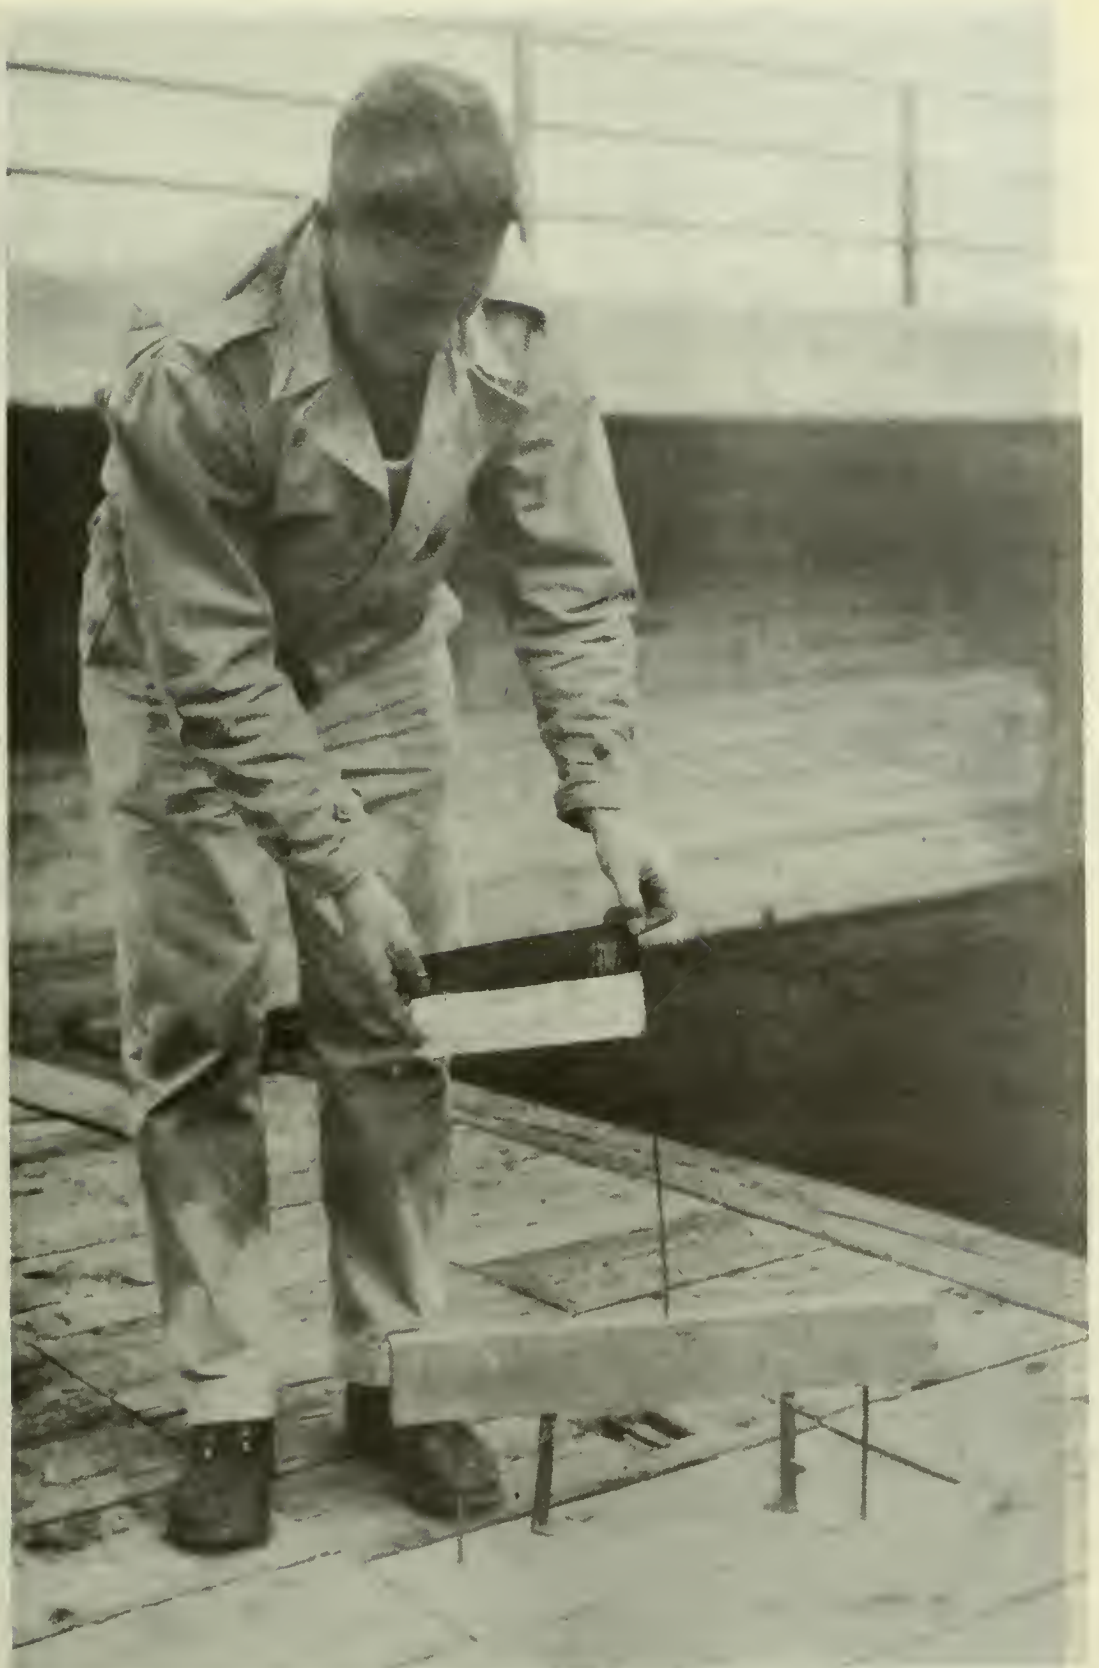
Figure 6.--Wooden float used in experiment to determine direction and influence of wind drift below Bonneville Dam.

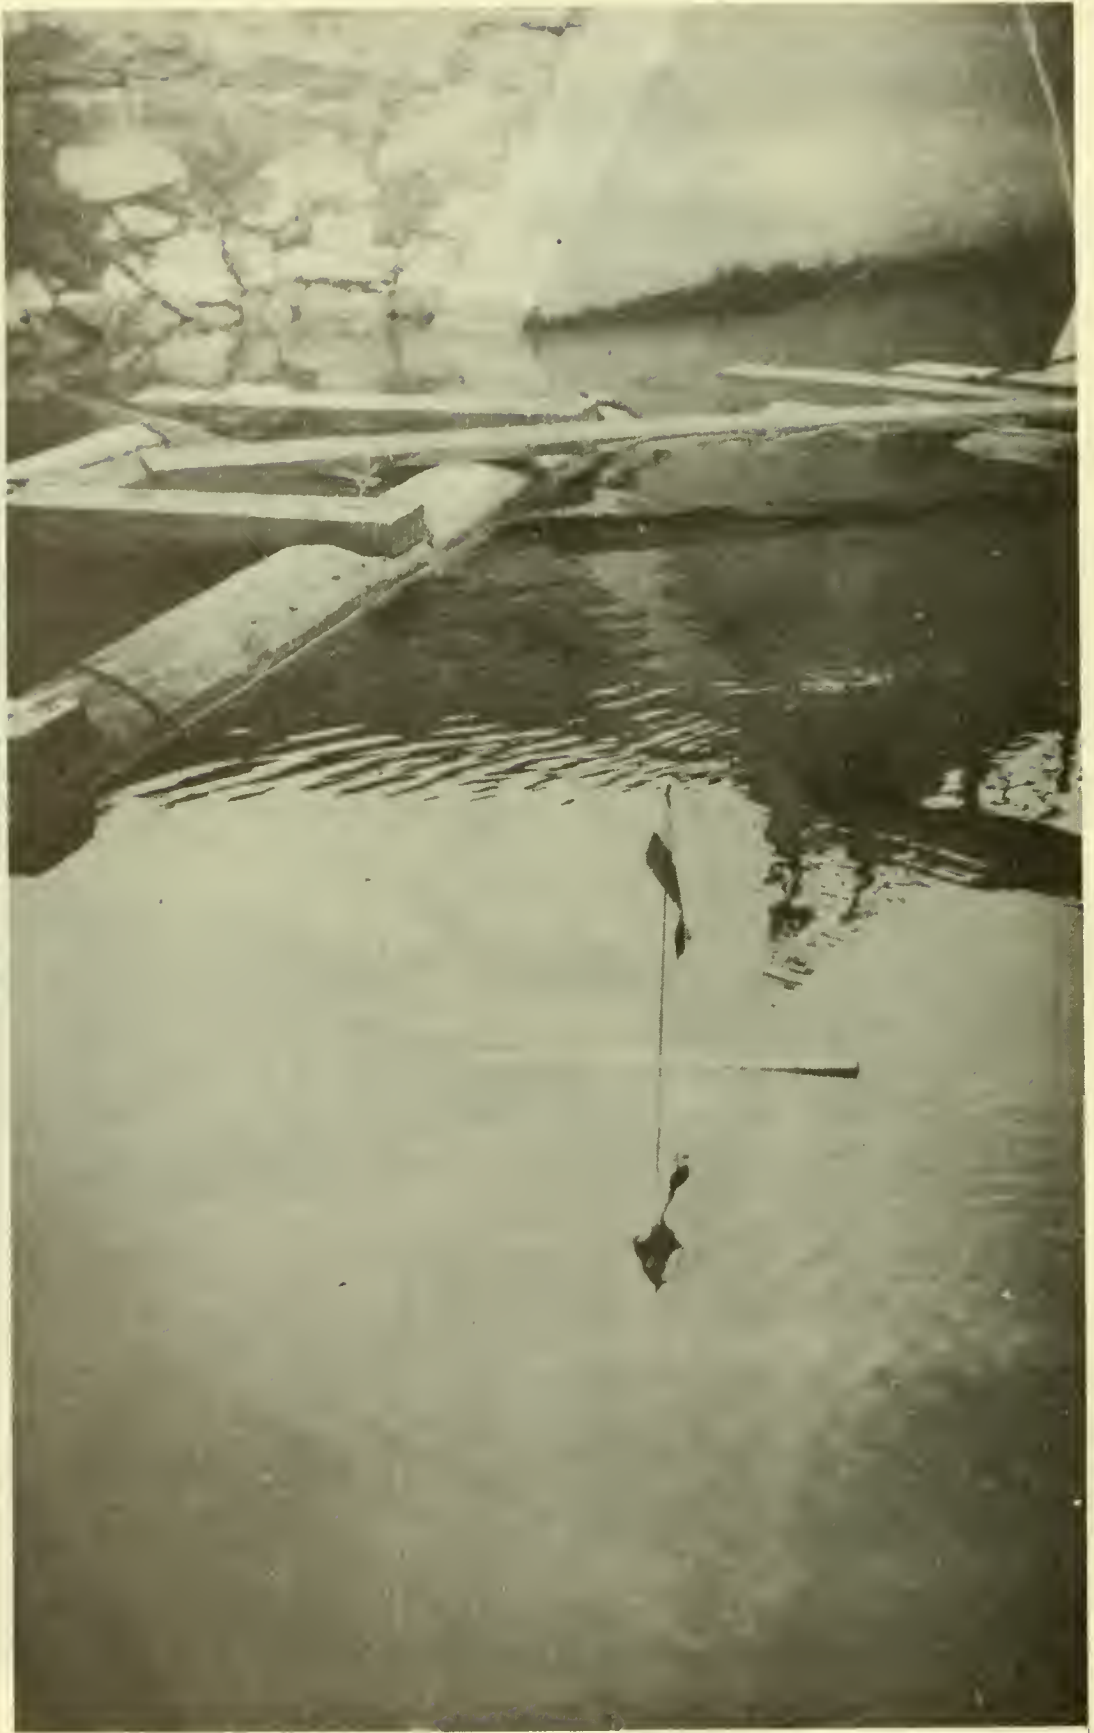
Figure 7.--Position of wooden float in water.

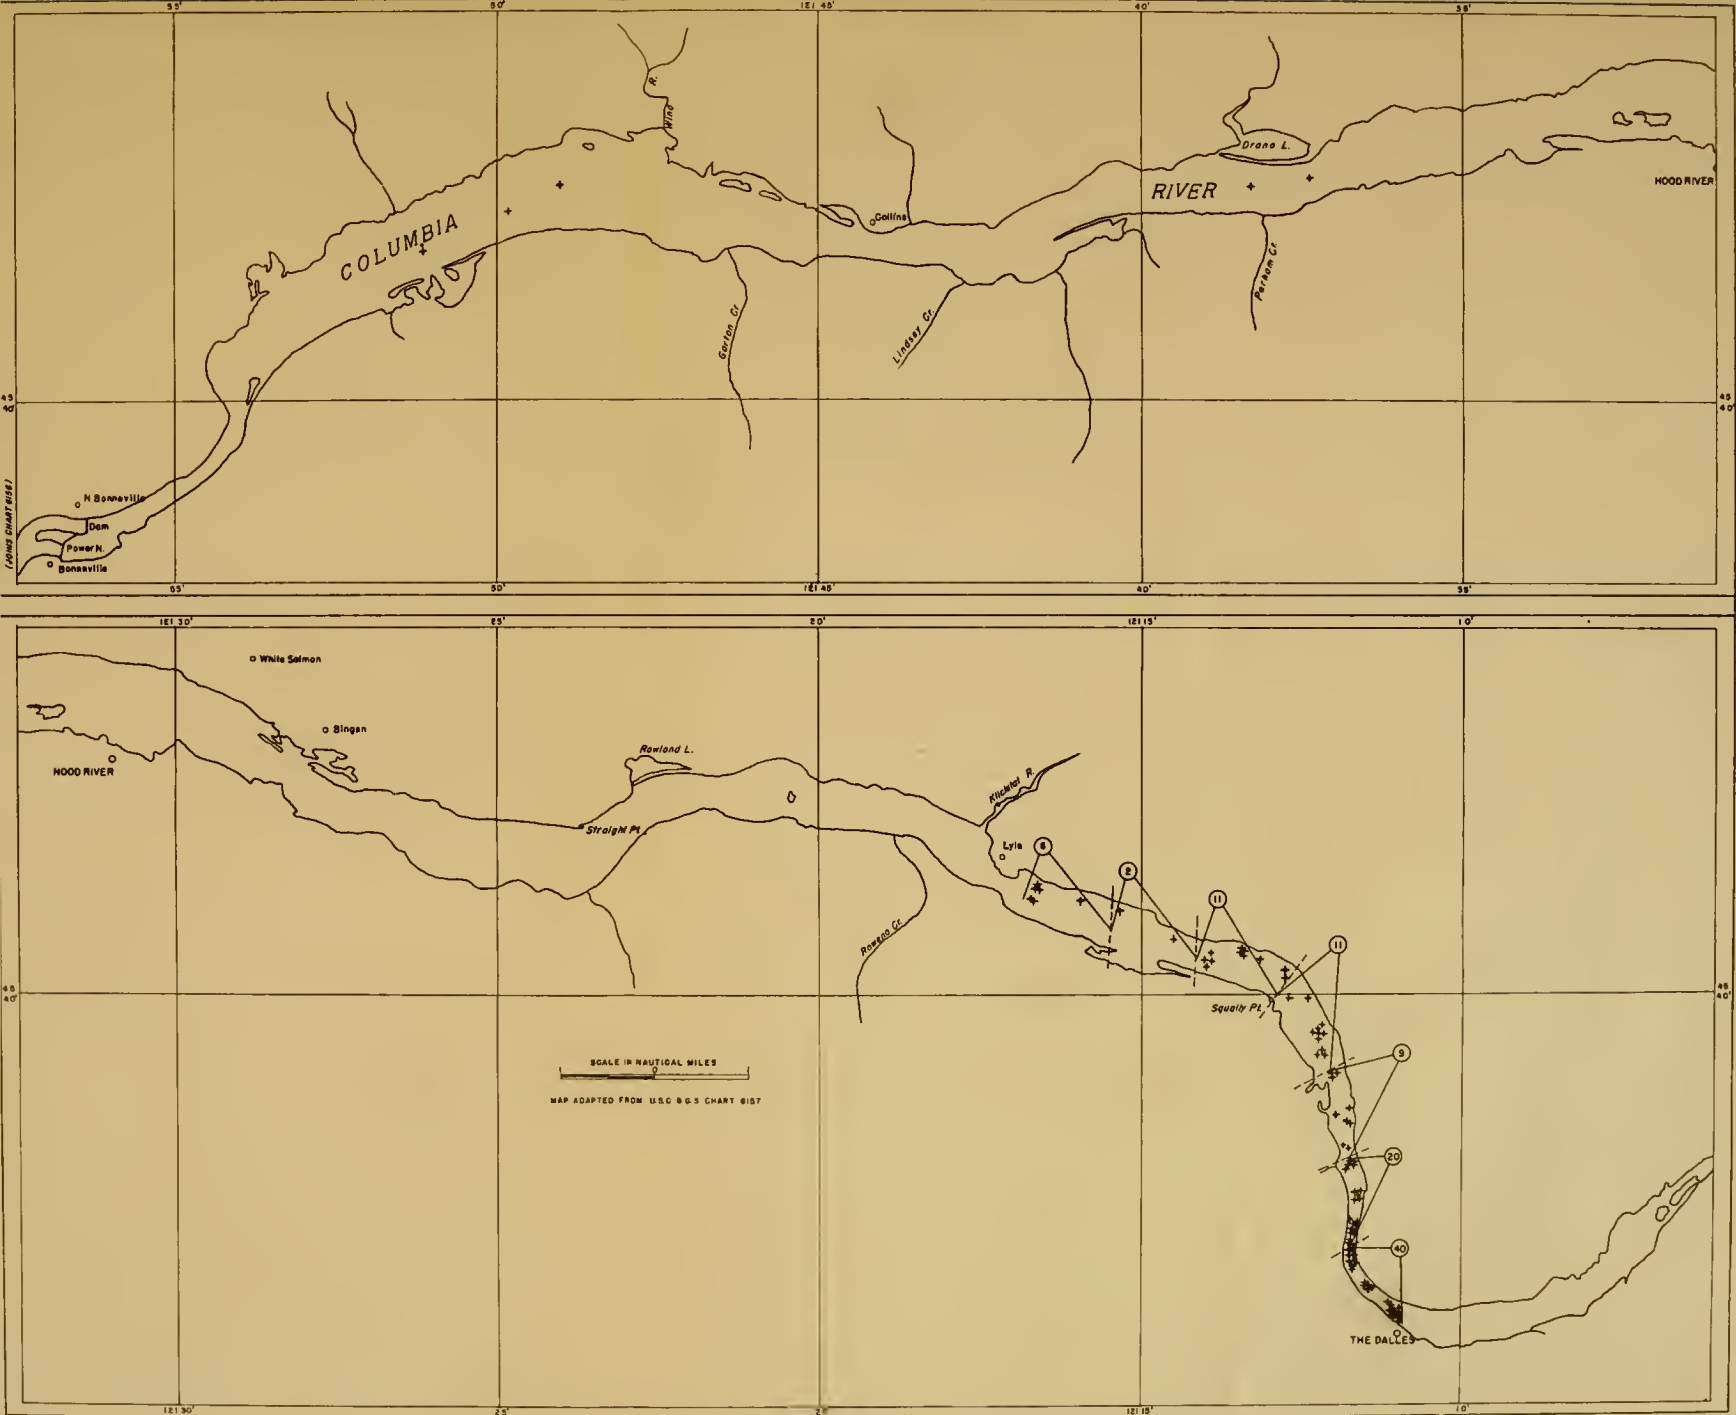
Figure 9.-- Approximate location and number of dead fish found between Bonneville Dam and The Dalles, Washington, 1946.

U. S. Coast and Geodetic Survey charts for the Columbia River from Vancouver, Washington, to The Dalles, Oregon have been reproduced in Figures 8 and 9, and have been marked off in 1-mile sections from The Dalles, Oregon, to Lyle, Washington, and from Bonneville Dam to Cape Horn, Washington. The numerals in the circles refer to the numbers of dead fish found in each 1-mile section. Only fish found in 1946 during the period of the fall run are included in the figures encircled. Figure 8 also includes 21 dead salmon and steelhead trout which were picked up just below the spillway section on September 6 and October 3, 1946.
